# **Fatigue of Composite Material Beam Elements Representative of Wind Turbine Blade Substructure**

John F. Mandell, Daniel D. Samborsky,  
David W. Combs, M. Ethan Scott,  
Douglas S. Cairns  
*Department of Chemical Engineering  
Montana State University  
Bozeman, Montana*

November 1998

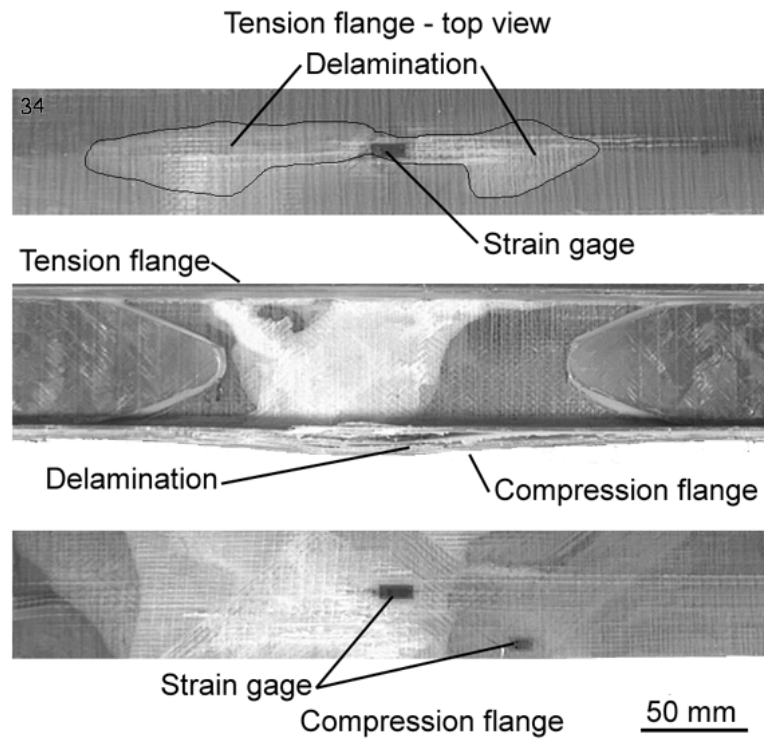
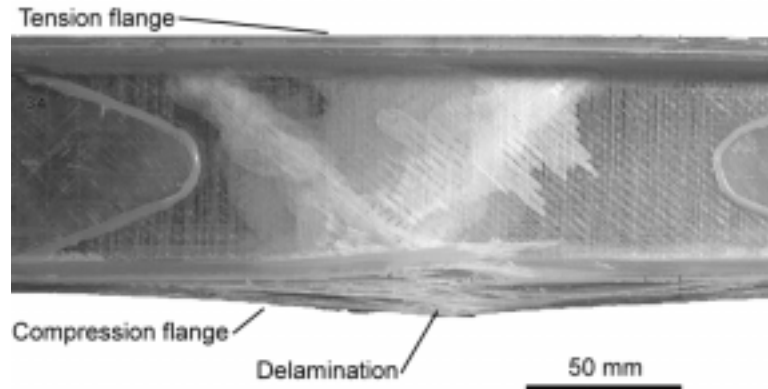
**Figure 105. Beam 34.**

Beam 34 involved a static test. The beam was loaded under actuator displacement control at a rate of 0.075 mm/s until failure, which involved a total ramp time of 65 seconds and a total mid-span deflection of approximately 8 mm. An initial beam stiffness of 4,990 kN/m was measured. The beam had two additional strain gages on the compression flange edges, both top and bottom of the flange. This was done to determine when the flange starts to buckle. The beam was loaded statically to 60 kN three times before the actual static test. The initial load - flange absolute maximum strain graph is shown in Figure 103 and shows the two standard strain gages on the center of the tension and compression flanges. Figure 104 shows the two compression flange edge gages, back-to-back, which indicates that the onset of buckling in this beam occurs at approximately 75 kN or 1.4% strain. The third load-up involved the static test and indicated a maximum tension flange strain of 1.92% and a minimum compression flange strain of -1.69% that occurred at a ultimate applied load of 83.22 kN. The failure occurred on the compression flange at  $x = 292 \pm 20$  mm. The compression flange had transverse tension cracks and multiple delaminations between  $x = 150$  and 457 mm. The delaminations extended through the web and into the adhesive layer on the tension flange, producing a delamination from  $x = 178$  to 381 mm. The failed beam is shown in Figures 105 and 106.

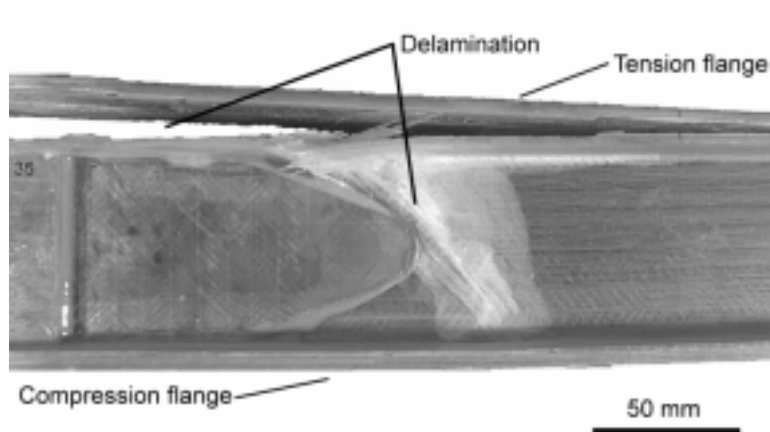
**Figure 108. Beam 35.**

Beam number 35 was fatigued at a rate of 2 Hz under sinusoidal load control with a maximum load of 62.3 kN and a minimum load of 6.3 kN. The maximum load produced an initial maximum tension flange strain of 1.04% and a minimum compression flange strain of -1.02%. The initial beam stiffness was measured as 4,347 kN/m. The compression flange delaminated from  $x = -75$  to 458 mm, after 9,771 cycles. The delamination of the flange caused the web to fail at  $x = 190$  mm with delamination in the web from  $x = 178$  to 267 mm. There were two spot delaminations on the tension flange, caused by the failure, at  $x = 190$  to 356 mm. The failed beam is shown in Figures 107 and 108.

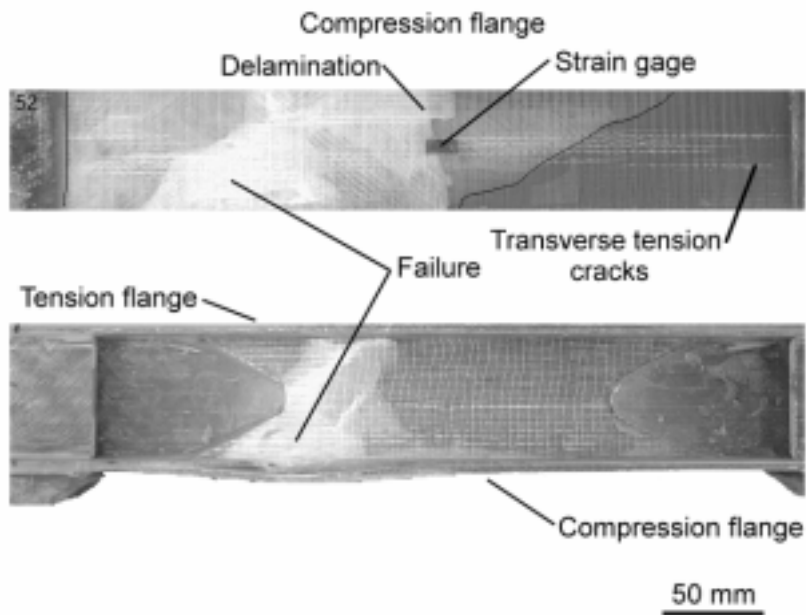
**Figure 111. Beam 52.**

Beam number 52 was fatigued at a rate of 3 Hz under sinusoidal load control with a maximum load of 62.3 kN and a minimum load of 6.2 kN. The maximum load produced an initial maximum tension flange strain of 0.93% and a minimum compression flange strain of -0.89%. The initial beam stiffness was measured as 5,145 kN/m. Initially the compression flange showed no evidence of buckling, but after 16,000 cycles, it was noticed that the compression flange had a small localized buckling node at  $x = 395$  mm that was present on only one flange edge. This node, or area of increased localized displacement, did not change until the failure of the beam after 62,843 cycles. The compression flange failed at  $x = 395$  mm, the node, with multiple delaminations in the preform and flange. The compression flange delaminations extended from  $x = 200$  to 460 mm and were between the 0° ply and adjacent 45° plies throughout the flange and preform thickness. This delamination also traveled into the web. The failed beam is shown in Figure 111.

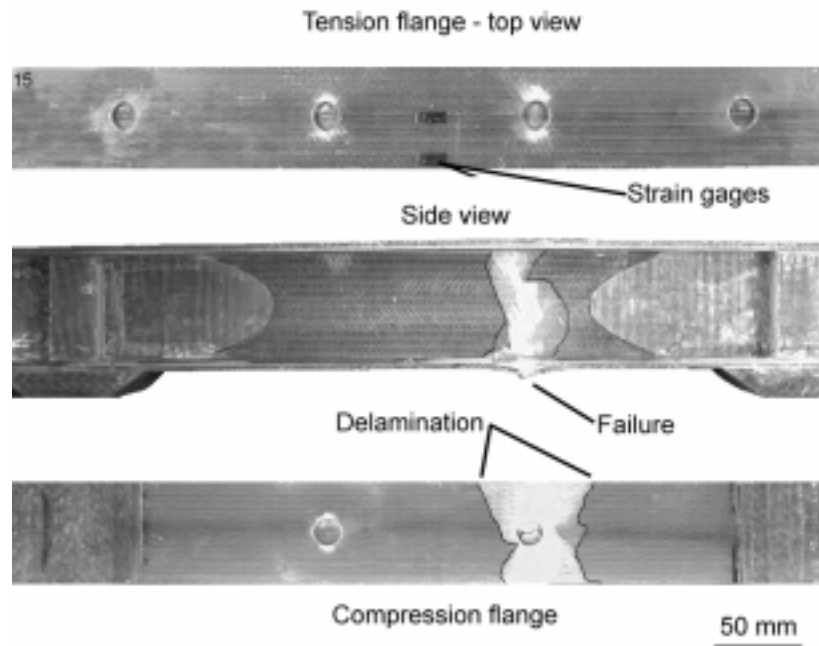
**Figure 115. Beam 15.**

Beam number 15 was fatigued at a rate of 1 Hz under sinusoidal load control with a maximum load of 31.1 kN and a minimum load of 3.1 kN. The maximum load produced an initial maximum tension flange strain of 0.83% and a minimum compression flange strain of -0.78%, both measured between hole locations. The initial beam stiffness was measured as 3,260 kN/m. The stiffness was checked after 2,163 cycles and was 3,064 kN/m or 94% of the original stiffness. The tension flange had two strain gages: one in the center of the flange and another at the edge. During the initial load up, at 18 kN, the center gage indicated 0.419% strain, while the edge gage was 0.429%, which is no significant difference. During the fatigue test, damage started to develop at all the holes and grew until it reached the edge of the flange. The beam failed after 2,772 cycles, in compression with the compression damage at  $x = 254$  mm. Multiple delaminations between the  $0^\circ$  and  $+45^\circ$  plies from  $x = 229$  to  $x = 286$  mm were also present. The compression flange failure and delamination caused an additional delamination to travel into the web at  $x = 244$  to  $x = 279$  mm. The failed beam is shown in Figure 115. No shear stiffener, torsional stiffener damage or delaminations were visible.

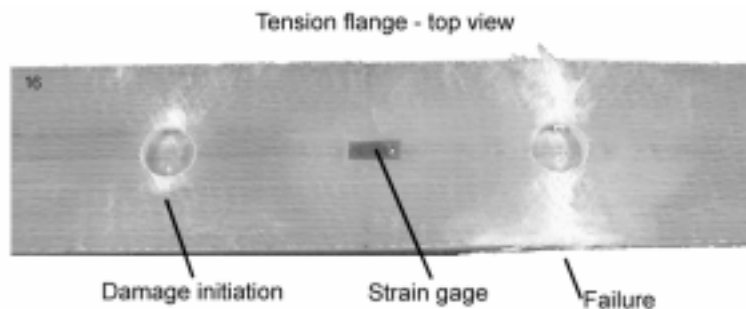
**Figure 117. Beam 16.**

Beam number 16 was fatigued at a rate of 5 Hz under sinusoidal load control with a maximum load of 24.5 kN and a minimum load of 2.5 kN. The maximum load produced an initial maximum tension flange strain of 0.58% and a minimum compression flange strain of -0.53%. The initial beam stiffness was measured as 3,340 kN/m. During the fatigue test, damage started at the outside edges of the holes and continued to grow until failure after 40,448 cycles. The beam failed on the tension flange at  $x = 356 \pm 13$  mm with the underlying delamination between  $x = 325$  to  $x = 394$  mm. This delamination also traveled 25 mm down into the web. Prior to failure, the web had a large number of 1.0 to 1.5 mm long tensile cracks, all located at stitching cross over points. Although these small cracks probably did not have any influence on the failure, it is still disconcerting that every stitch cross-over point on the tension side of the neutral axis had a crack. Some minor delamination damage was present on the tension flange around the holes. No shear stiffener, torsional stiffener damage or delaminations were visible. The failed beam is shown in Figures 116 and 117.

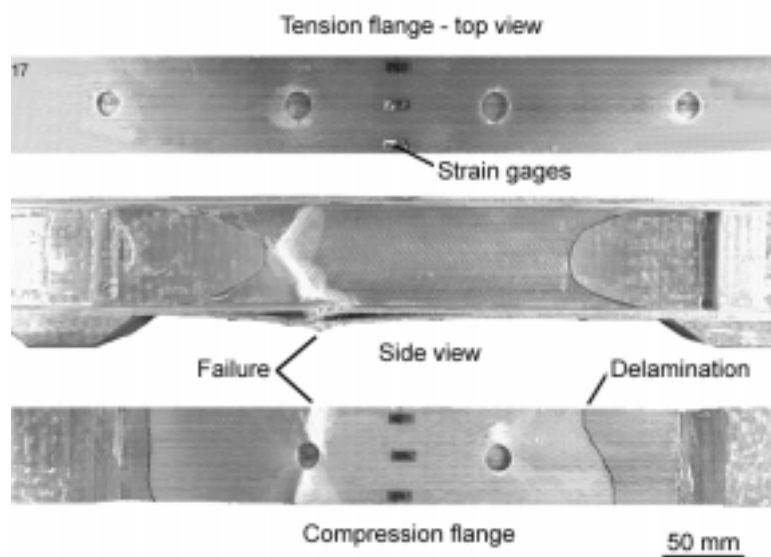
Figure 119. Beam 17.

Beam 17 was tested statically to failure. The beam was loaded under actuator displacement control at a rate of 0.05 mm/s until failure, which had a total ramp time of 196 seconds. An initial beam stiffness of 3,350 kN/m was measured. The beam had a total of six strain gages, with three on the tension flange and three on the compression flange. At 18 kN, the tension flange indicated a center strain of 0.334% while the two edge gages indicated 0.423% and 0.416%. The compression flange center gage indicated -0.365% and the two edge gages indicated -0.388% and -0.374%. The difference in strain from the center, where the flange is discontinuous, and the edge is more pronounced than the strains recorded from Beam 15. As the beam was loaded, the compression flange did not appear to twist as in the other beam static tests. The load-flange absolute maximum strain graph is shown in Figure 118, indicating a maximum tension flange center strain of 1.30% and a minimum compression flange center strain of -1.08%. These strains occurred at a ultimate applied load of 46.97 kN at a maximum mid-span deflection of 15 mm. The failed beam is shown in Figure 119. The compression flange failed at  $x = 260 \pm 15$  mm and created a flange delamination from  $x = 178$  to  $x = 419$  mm. The delamination was between the  $0^\circ$  ply (ply 10, Table 22) and  $+45^\circ$  ply (ply 11, Table 22). This delamination traveled up towards the tension flange and produced a spot delamination at the tension flange hole. The second hole on the compression flange had a 12 mm delamination going towards the edge, but the damage at the other hole produced the flange failure first.

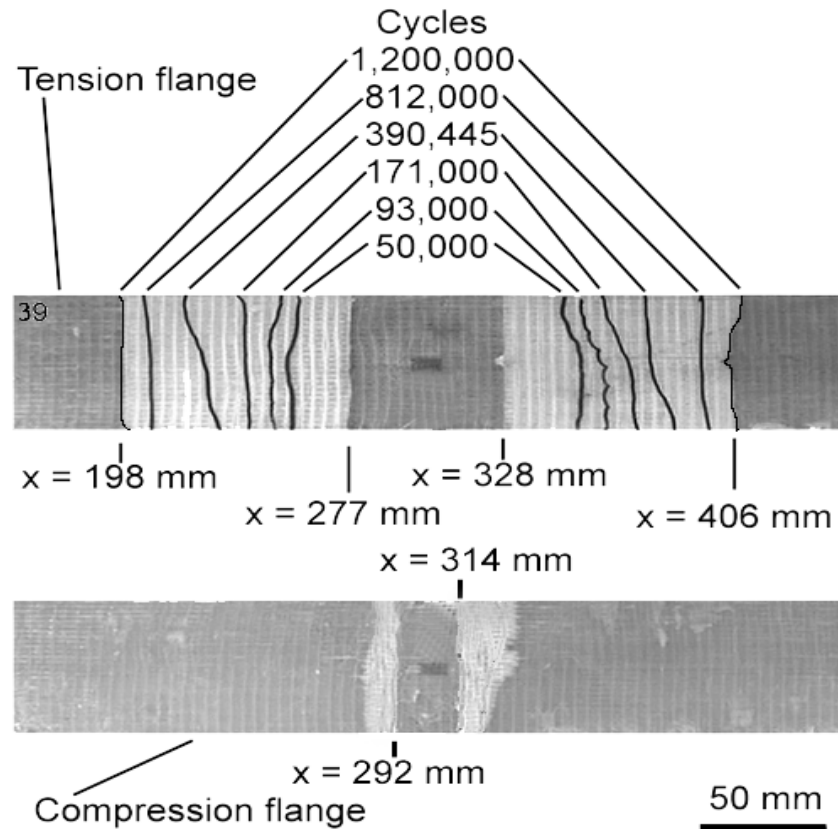
**Figure 120. Beam 39.**

Beam number 39 was fatigued at a rate of 4 Hz with a maximum load of 35.6 kN and a minimum load of 3.6 kN. The maximum load produced an initial maximum tension flange strain of 0.62% and a minimum compressive flange strain of -0.64%. The initial beam stiffness was measured as 4,804 kN/m. The flange material was the ESA laminate, which had a single, exterior ply drop (ply 1, Table 34). The ply drops on the tension flange were at  $x = 277$  and  $328$  mm. The ply drops on the compression flange were at  $x = 292$  and  $314$  mm. On the tension flange, the delamination started immediately between the surface  $0^\circ$  ply and second internal  $0^\circ$  ply (plies 1 and 2, Table 34). This delamination was uniform across the width of the tension flange. The delamination on the tension flange continued to grow at an average rate of  $6.95 \times 10^{-5}$  mm/cycle until the beam was taken out of the apparatus at 1,225,650 cycles. The tension flange itself did not delaminate from the web flange. The compression flange did not start to show delamination until approximately 11,000 cycles. The compression flange delamination also occurred between the two top  $0^\circ$  plies (plies 1 and 2, Table 34) and grew approximately 30 mm in length and then arrested for the duration of the test. Table 35 lists the average delamination length versus cycles. The beam is shown in Figure 120. No shear stiffener, torsional stiffener or other flange damage or delaminations were visible.

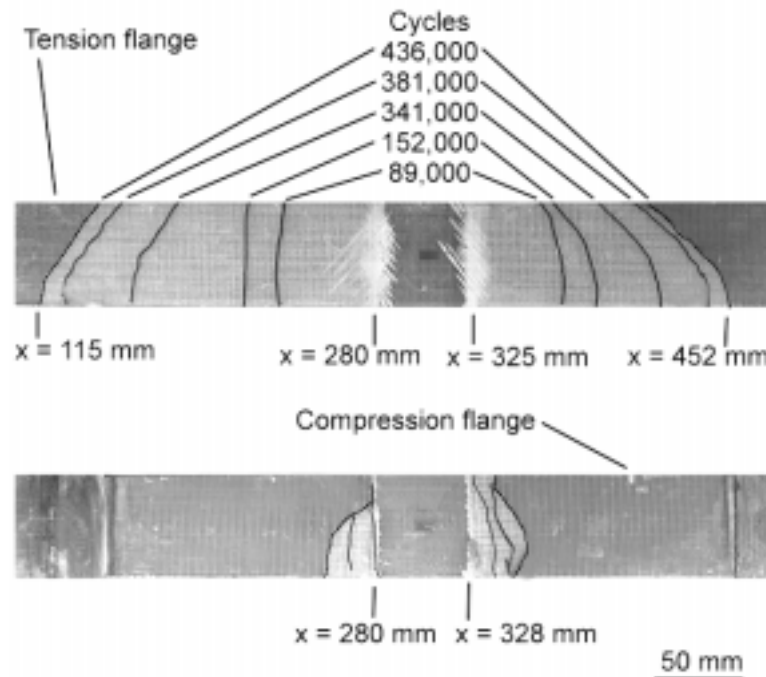
Figure 125. Beam 42.

Beam number 42 was fatigued at a rate of 4 Hz with a maximum load of 35.6 kN and a minimum load of 3.6 kN. The maximum load produced an initial maximum tension flange strain of 0.55% and a minimum compressive flange strain of -0.54%. The initial beam stiffness was measured as 5,524 kN/m. The only difference between Beam 42, as compared with Beam 41, is the strain level at which the beams were run. The tension flange ply drops were located at  $x = 280$  and  $325$  mm and the compression flange ply drops were at  $x = 280$  and  $328$  mm. The delamination appearing on the flanges were similar to Beam 41. On the tension side of the beam the delamination originally started between the  $0^\circ$  ply, (ply 2, Table 39) and the  $+45^\circ$  (ply 3, Table 39), but continued between the  $0^\circ$  ply (ply 5, Table 39) and the  $-45^\circ$  ply (ply 4, Table 39). The average delamination length versus cycles is listed in Table 41. The average calculated delamination rate on the tension flange was  $1.23 \times 10^{-4}$  mm/cycle. The compression flange did not start to delaminate until almost 100,000 cycles and the average calculated delamination rate was  $3.84 \times 10^{-5}$  mm/cycle. The delaminated beam is shown in Figure 125 below.

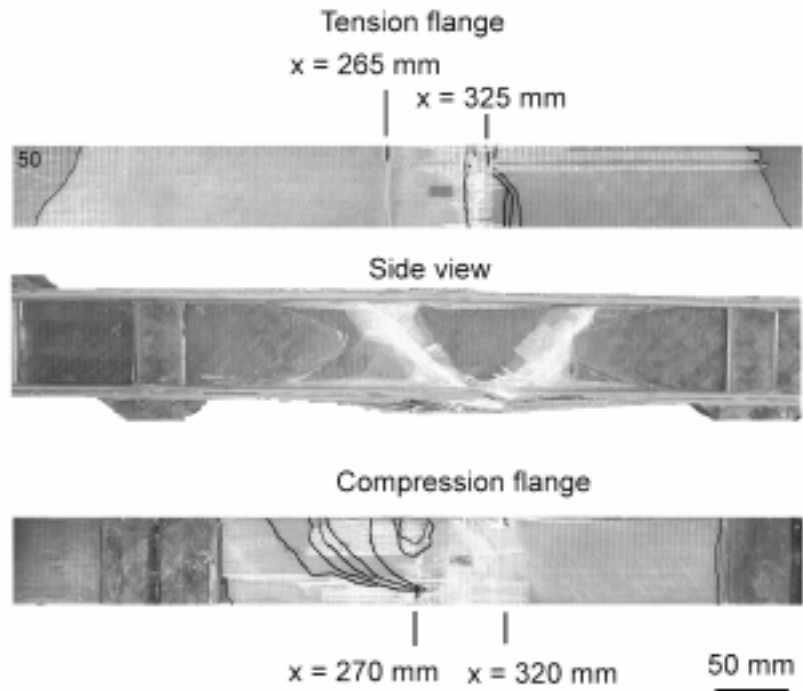
**Figure 127. Beam 50.**

Beam number 50 was fatigued at a rate of 3 Hz with a maximum load of 48.9 kN and a minimum load of 4.9 kN. The maximum load produced an initial maximum tension flange strain of 0.63% and a minimum compressive flange strain of -0.63%. The initial beam stiffness was measured as 6,054 kN/m. The tension flange ply drops were located at  $x = 265$  and  $325 \text{ mm}$  and the compression flange ply drops were at  $x = 270$  and  $320 \text{ mm}$ . Delamination started into the thin section of the tension flange and then arrested, just as with previous beams. The average delamination length versus cycles is shown in Table 44. The delamination on the tensile flange started into the thick cross-section and propagated uniformly at an average calculated rate of  $5.08 \times 10^{-4} \text{ mm/cycle}$ . The compression side of the beam showed delamination being initiated at one corner of the ply drop and slowly working its way along the flange edge and then across the flange. Once the crack had propagated across the flange width, the delamination grew unstably to the load pads. The beam was then tested for residual strength after 204,100 cycles. The residual strength was 88.2 kN. The failed beam is shown in Figure 127, indicating a compression flange failure. This failure load compares favorably with that for Beam 34, 83.22 kN, with no ply drops, but thinner flange material.

Cycles	Average Tension Flange Delamination, mm
500	4
2,500	19
7,000	24
12,000	30
31,800	30
82,000	30
105,000	43
131,000	52
176,000	102
204,100	102
